Dam ID: HI00007  
Kepani

Inspection No: \_\_\_\_\_  
Date: 03/22/2006

STATE OF HAWAII - DLNR  
VISUAL DAM SAFETY INSPECTION SHEET

Inspection Type: Visual Dam Safety Inspection

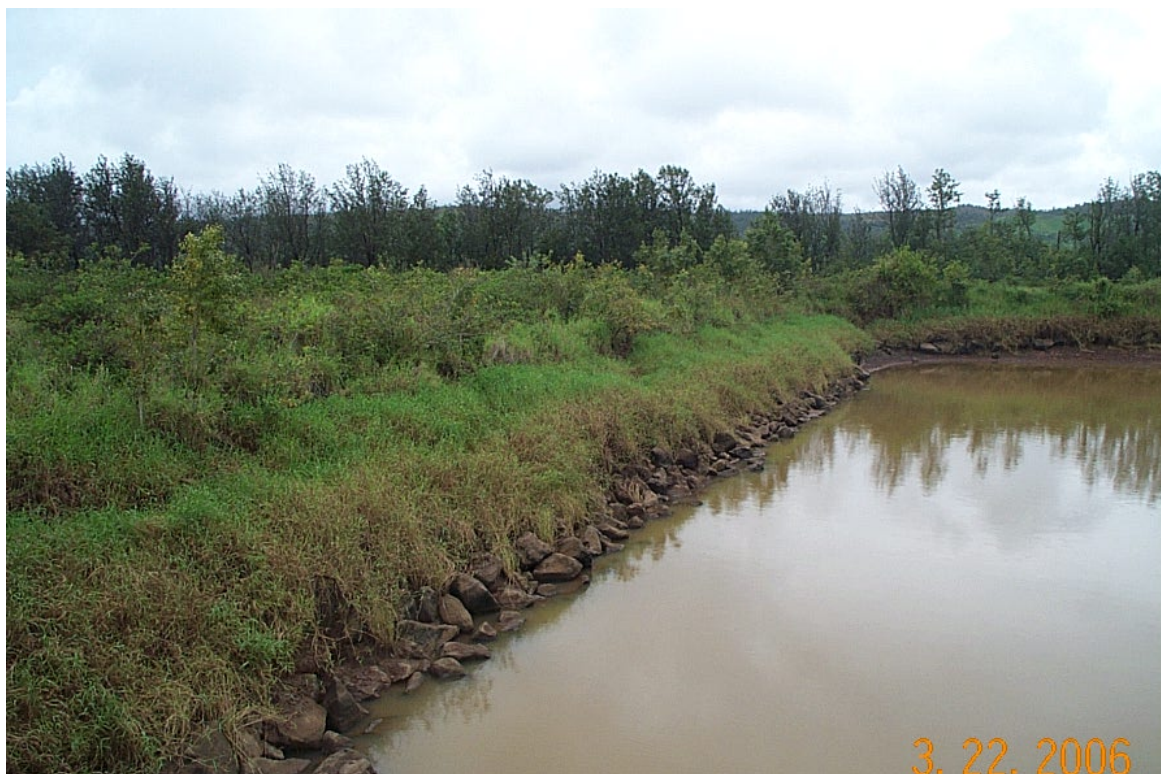
- ☐ a. The upstream slope was not inspected.
- ☐ b. The upstream slope appeared to be in satisfactory condition, no corrective actions are required at this time.
- ☒ c. The upstream slope appeared to be in fair to poor condition and requires corrective action.
- ☐ d. The upstream slope appeared to be in unsatisfactory condition and not expected to fulfill its intended function. Urgent corrective action is required.

HI00007 - Kepani Reservoir: Upstream slope of the dam. Note riprap along the water's edge.

- ☒ k. Owner should periodically remove vegetation as necessary to keep clear.

1. Owner should continue with removal of vegetation on the upstream and downstream slopes and crest. The slopes should be clear and visible for inspection. If existing trees have been allowed to grow so large in some cases that there is concern that seepage and piping (i.e. internal erosion) along root systems may develop. There is additional concern that cutting and killing the trees will lead to rotten roots and greater potential for such seepage and piping. A more in depth evaluation of the condition should be performed to determine how best to remediate the condition.

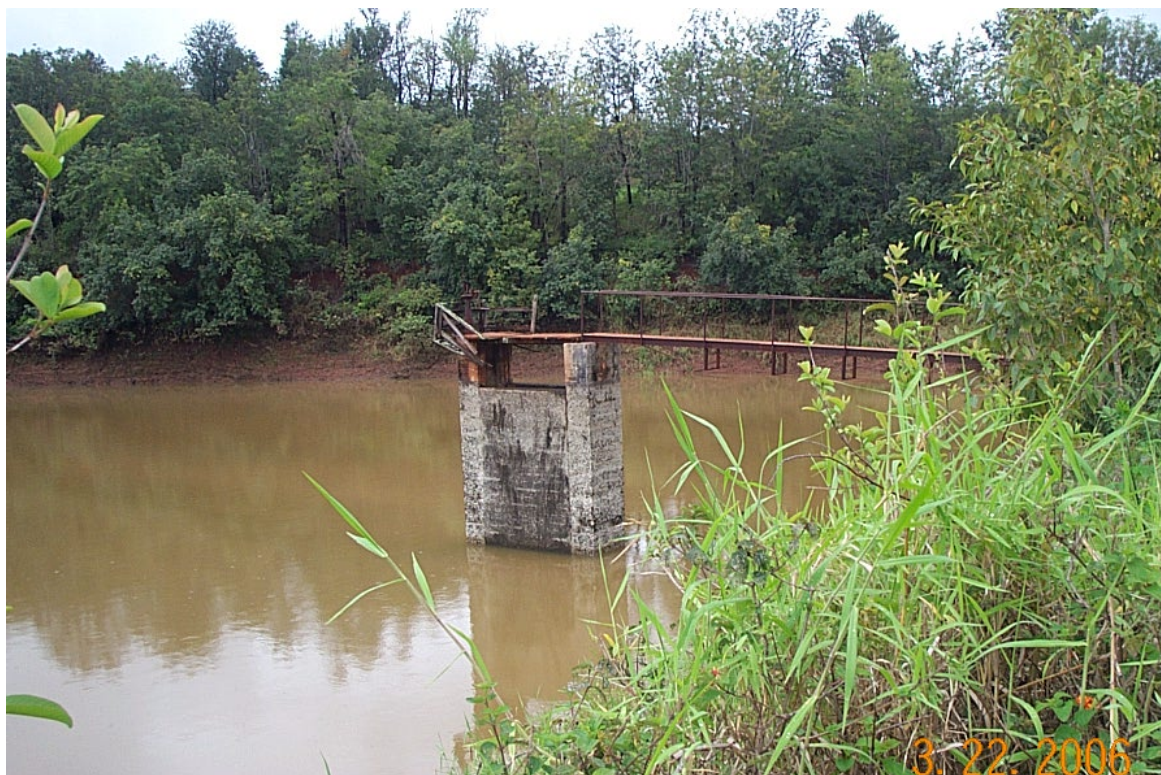
HI00007 - Kepani Reservoir: Outlet works inlet structure.

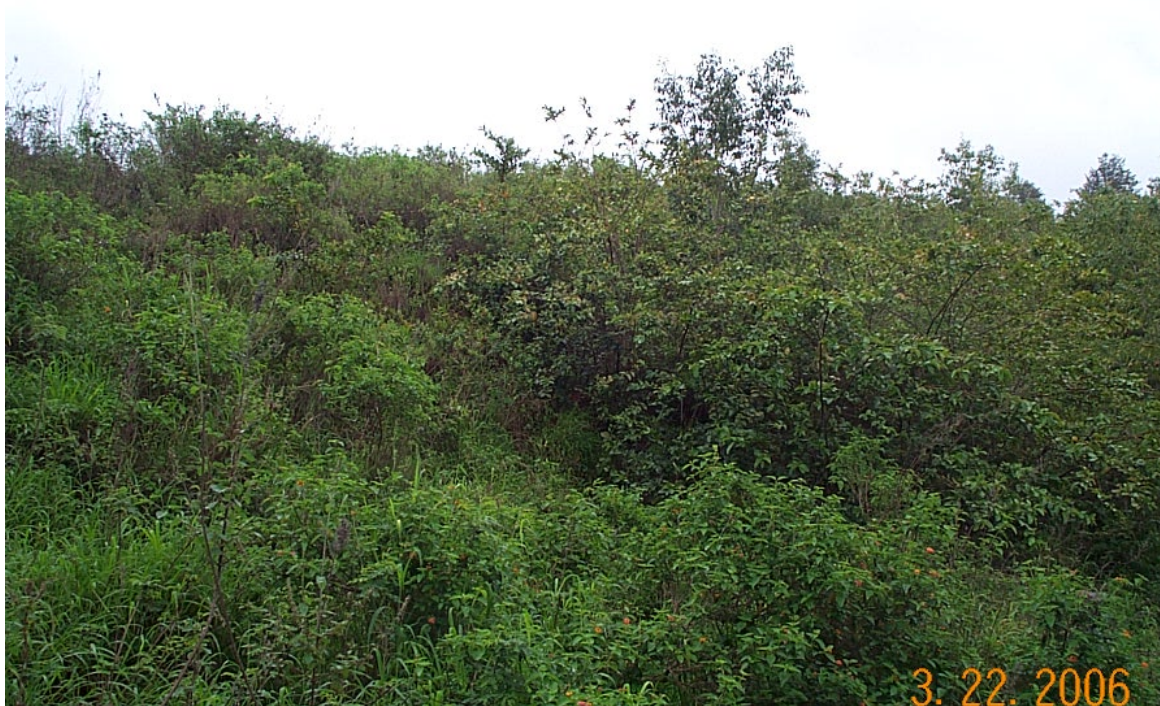
Description: Vegetation made inspection difficult.

- ☐ a. The downstream slope was not inspected.
- ☐ b. The downstream slope appeared to be in satisfactory condition, no corrective actions are required at this time.
- ☒ c. The downstream slope appeared to be in fair to poor condition and requires corrective action.
- ☐ d. The downstream slope appeared to be in unsatisfactory condition and not expected to fulfill its intended function. Urgent corrective action is required.

HI00007 - Kepani Reservoir: Downstream slope of dam. Note heavy vegetation.

- ☐ j. The slope was very steep, around a 1 to 1 slope, further study is required to verify slope stability.
- ☒ k. Owner should periodically remove vegetation.

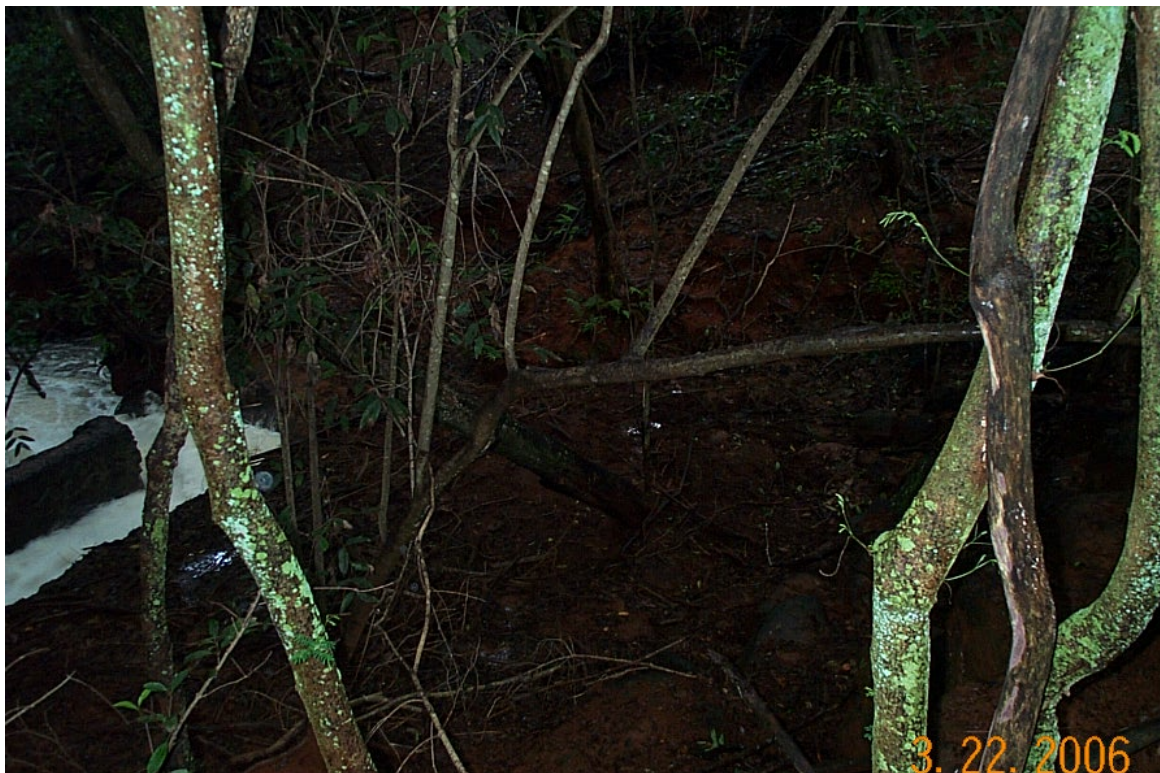
Seep Spot Number 2  
☐ Green Vegetation ☒ Wet or Muddy Ground ☒ Ponding Water ☐ Not Visible ☐ None Observed  
☒ Flowing, Description: less than 5 gpm  
Water Clarity: ☒ Clear ☐ Some particles ☐ Muddy ☐ Other: \_\_\_\_\_  
Description: Seepage area located at excavation below outlet works at the port where the flume makes a 90 degree left turn.

HI00007 - Kepani Reservoir: View of the seepage area below the outlet works. Note the irrigation ditch to the left side of photo. Seepage is uniformly distributed in the center of photo.

- ☒ l. Monitor the seepage areas for change in flowrate or condition (i.e., muddy water, soil movement)

5. Seepage was observed below the outlet works. A V-notch weir, Parshall flume, etc., should be installed to collect & monitor/measure the rate or volume of seepage with respect to changes (i.e. increase & decrease) in reservoir (pool) elevation.

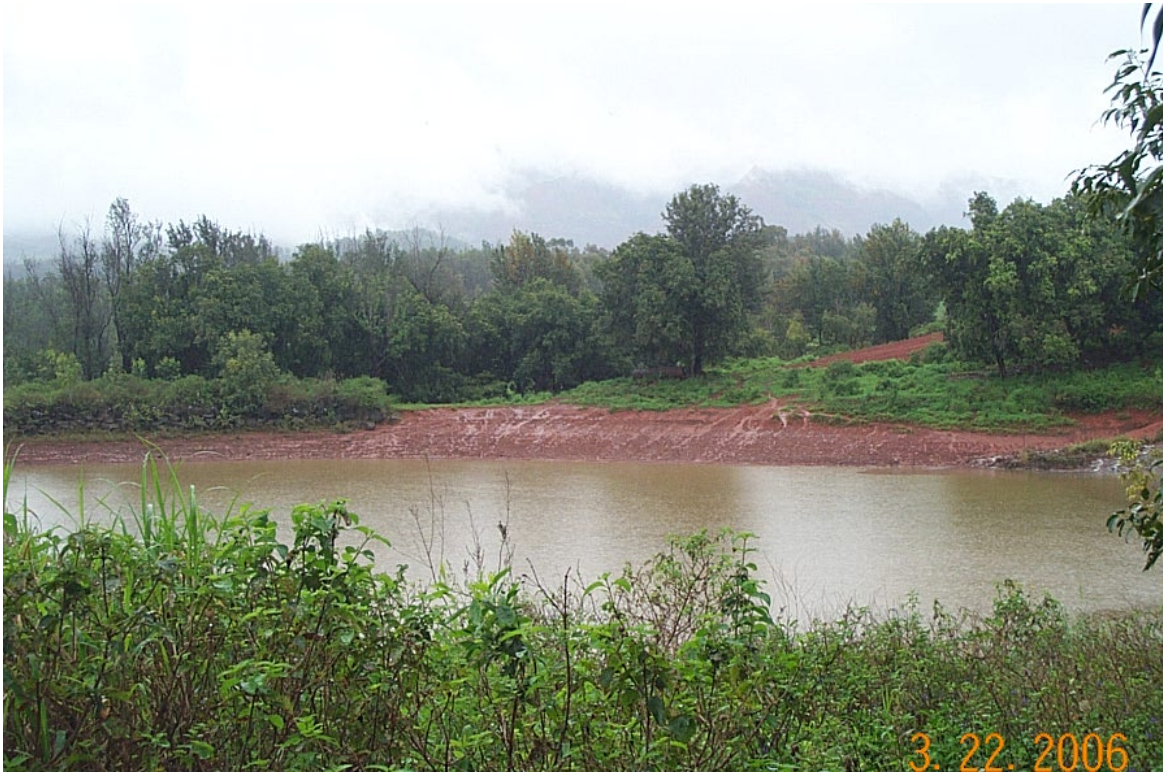
- ☒ a. The Spillway appeared to be in satisfactory condition, no corrective actions are required at this time.  
☐ b. The Spillway appeared to be in fair to poor condition and requires corrective action.  
☐ c. The Spillway appeared to be in unsatisfactory condition and not expected to fulfill its intended function. Urgent corrective action is required.

HI00007 - Kepani Reservoir: View of the spillway on the other side of the reservoir. Spillway is in center of photo.
